# TECHNICAL REPORT ON ELECTRICAL CABLE UPGRADE IN ST. FRANCIS IFAKARA HOSPITAL

**Location:** St. Francis Ifakara Referral Hospital

**Prepared by:** AG Technical Team

**Date:** 17/04/2026

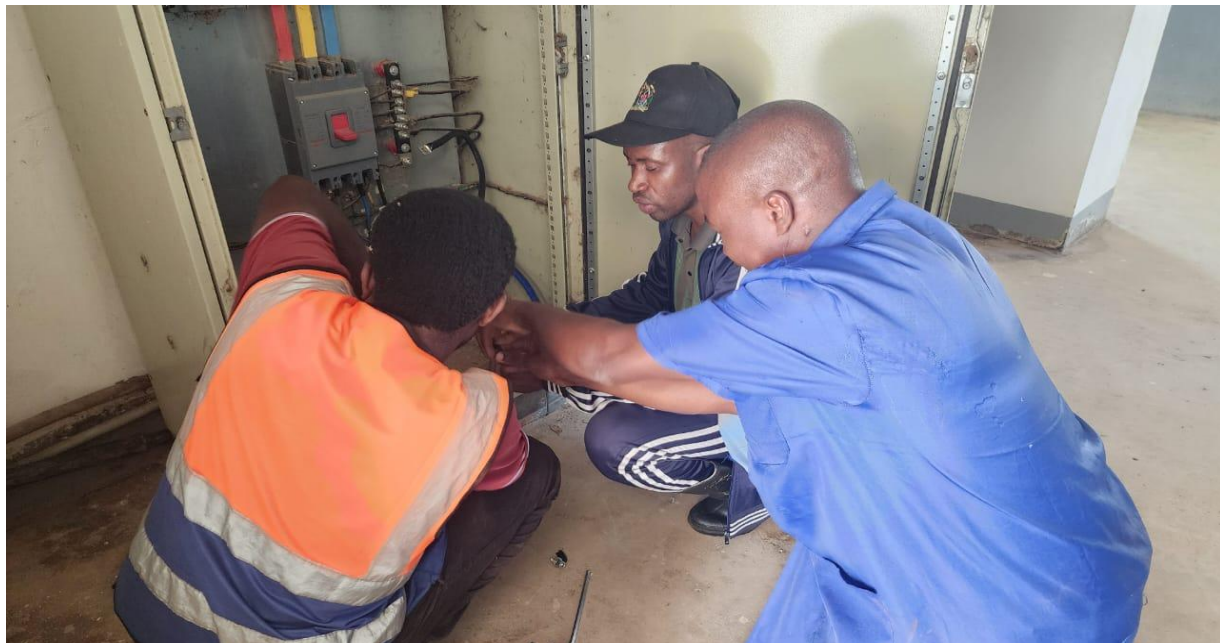
Image 1: Technical team together with St. Francis Ifakara Mission Hospital General Manager they are installing 4 core 95mm<sup>2</sup> Armoured cable

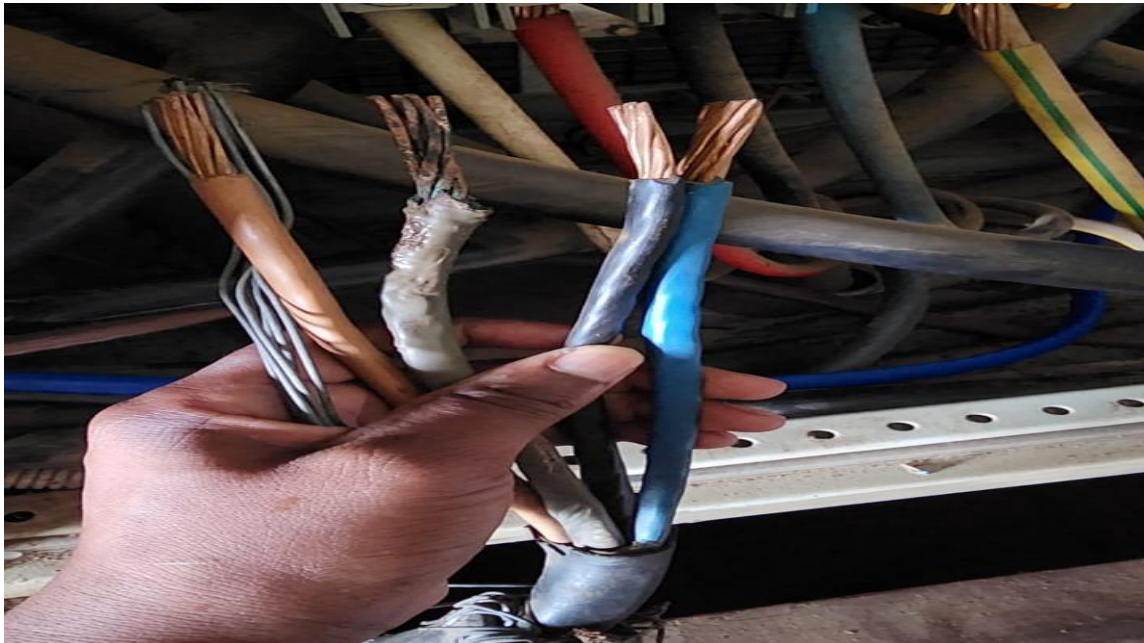
An existing **4-core 25mm<sup>2</sup> cable** connected to the general power cabinet was experiencing overheating due to excessive electrical load.

Image 2: 4 core 25mm<sup>2</sup> which was removed, it was supplying power from Power house to general cabinet

The overloaded cable was replaced with a higher-capacity **4-core 95mm<sup>2</sup> armored cable**.

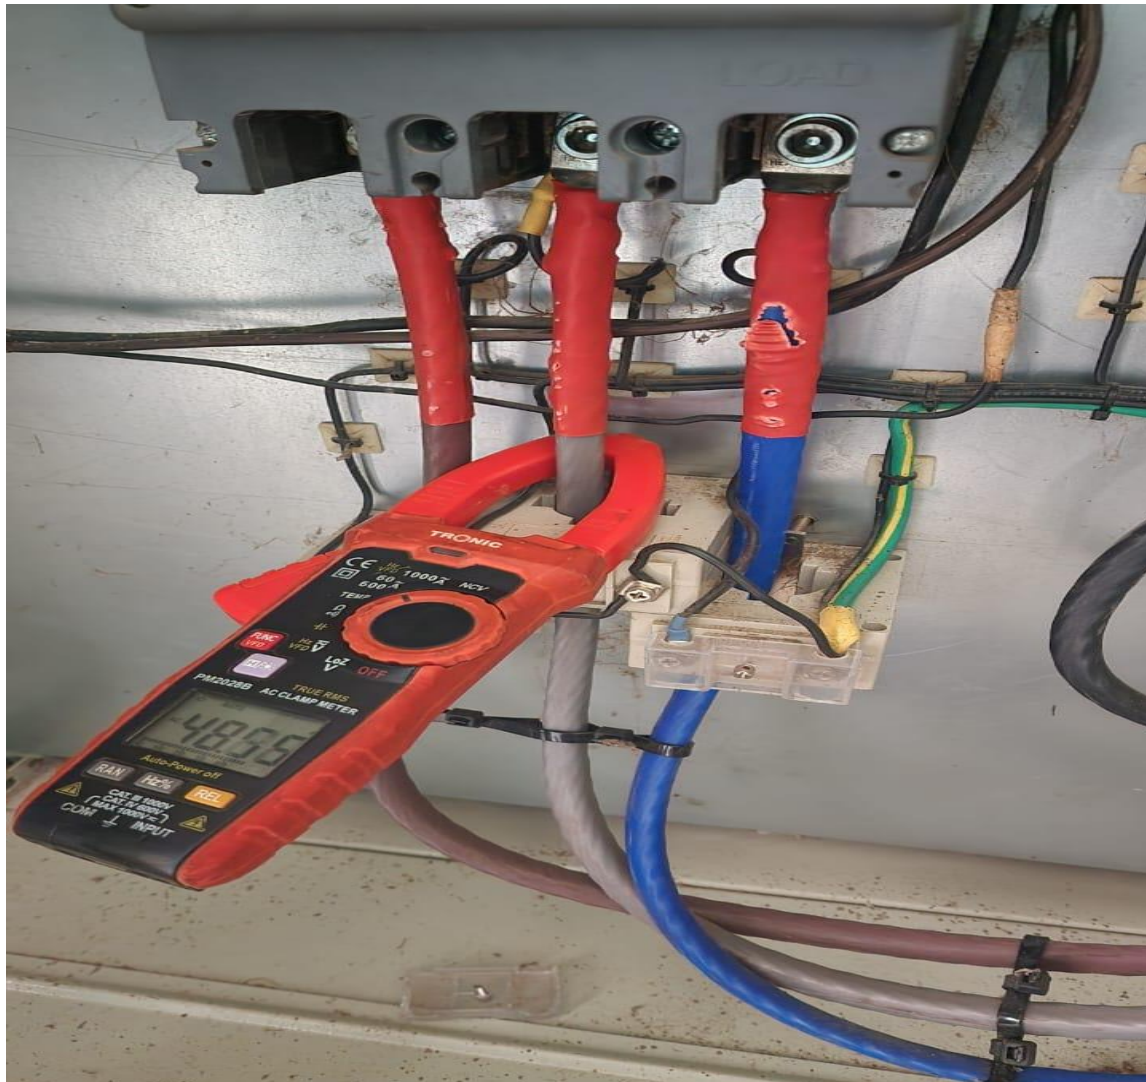
The overheating issue in this section has been successfully resolved, and power distribution is now stable.

Image 3: New installed cable 4core 95mm<sup>2</sup> from Power house (Gen house ) to general cabinet

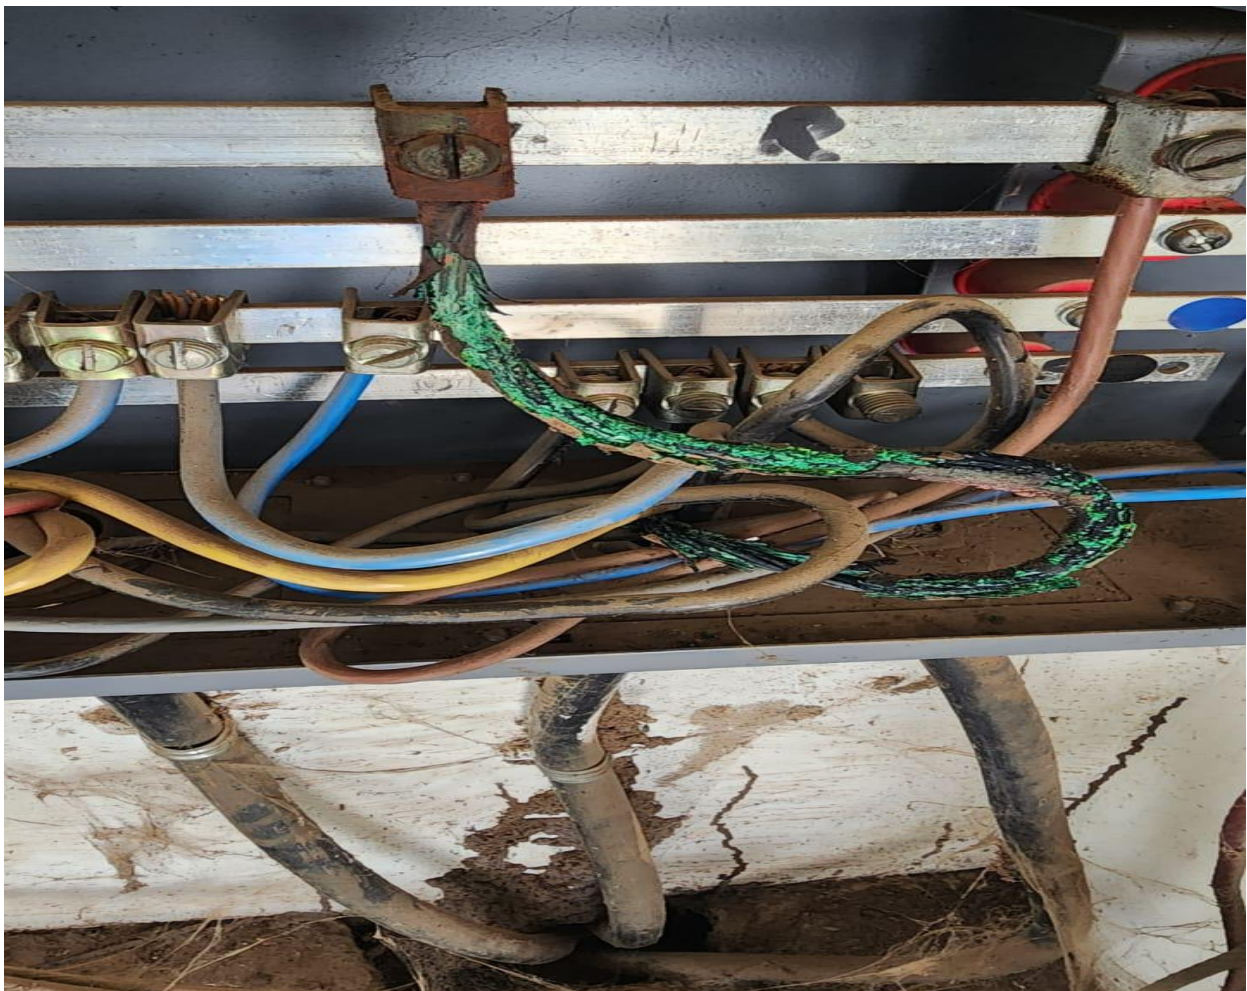
The cable running from the CDSI power cabinet to the distribution cabinet (serving the Oxygen Plant, Dialysis, Infusion Block, Pediatric Ward, Mental Health Unit, and ICU) is also overheating.

- Existing cable: **4-core 25mm<sup>2</sup> armored cable**
- Condition: Overloaded and at risk of failure

Image 4: 4core 25mm<sup>2</sup> Armoured cable is getting overheated

The current cable is insufficient for the load demand and poses a risk of overheating and potential failure. Upgrading to a larger cable size will improve load handling capacity, enhance safety, and ensure uninterrupted operation of critical hospital services.

- Replace the existing cable with:  
**4-core 50mm<sup>2</sup> armored cable**
- Required length: **85 meters**
